NASA Contractor Report 175052 USAAVSCOM Technical Report 86-C-14

Axial and Torsional Fatigue Behavior of Waspaloy

S. Zamrik, M. Mirdamadi, and F. Zahiri

The Pennsylvania State University

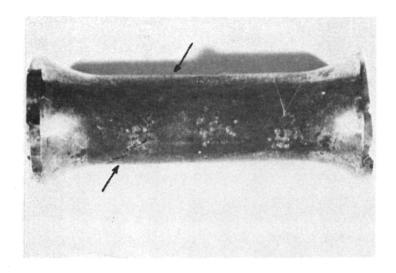
Figure 1 shows the failure mode of a coarse grained test specimen that failed under torsional shear strain range continuous cycling at 1200 °F. The failure mode shows a transition from shear observed at room temperature to tensile stage at 1200 °F. To verify this 45° crack mode, duplicate tests were conducted at two levels of plastic shear strain ranges, one at $\Delta \gamma_p = 0.52 \text{ percent to failure and the other at } \Delta \gamma_p = 92 \text{ percent to failure.}$ In both cases, the failure mode was tensile with cracks at 45° mode as shown in figure 2.

Fig. 1 a) Macrophoto of Waspaloy course grain torsional 1200°F. (Spec. BF27, $\Delta \Upsilon_T$ =1.58%, $\Delta \Upsilon_P$ =0.65% @ N_f/2, N_f=4528) Note primary cracking at 45° to specimen axis on planes of maximum tensile stress.

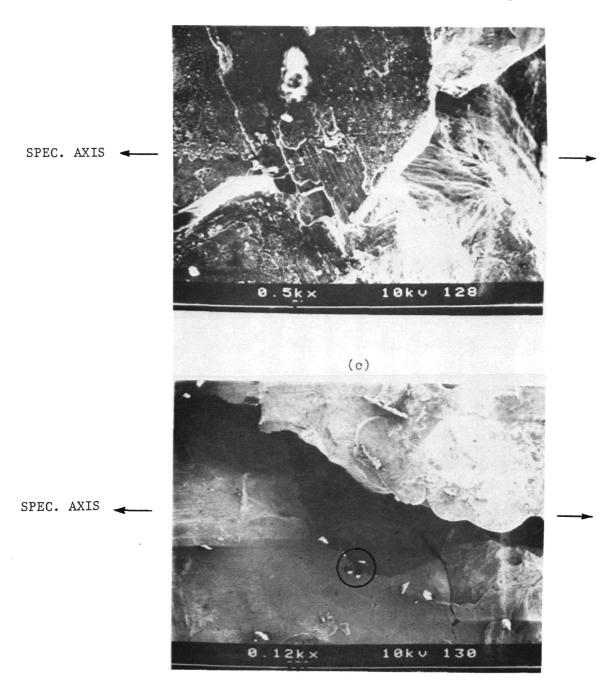
45° with respect to specimen axis. The zigzagging crack path shown in figure 3(b) was studied with an enlargement shown in figure 3(b). The progress of the crack was hindered by grains that saw little plastic deformation (slip bands activities) and were in elastic condition forcing the crack to deviate. This is shown clearly in figure 3(c). Furthermore, at 1200°F, carbides and precipitates were observed on slip bands and on grain boundaries as shown in figure 3(e). Therefore, the tensile failure mode can be attributed to the embrittlement of these carbides, assisted by an oxidation that enhanced the embrittlement process. Embrittled regions are sensitive to normal stresses. Figure 3(e) also shows additional large particles. The chemical composition of these large particles was found, by x-ray energy spectrum analysis (fig. 4), to be the same material as that of the matrix. These large particles have also initiated crack sites that contributed to mode I cracking. With respect to the slip mode characteristic, it was found in all cases to be planar slip that resulted in γ' particles shearing.

Fig. 3 a) Primary crack at 45° to the specimen axis (Spec. BF4) on planes of maximum tensile stress.

b) Enlarged region of (a) showing slip band formation and crack orientation and propagation. It also shows undeformed grain ahead of the crack front forcing the crack to change direction.

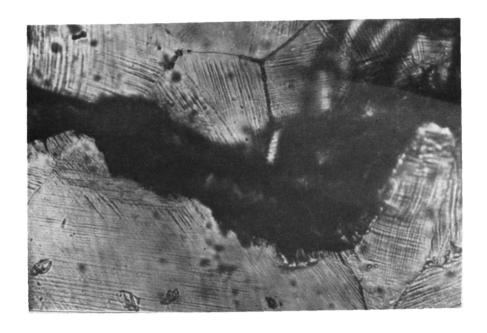
The test at 1200 °F under 90 sec hold time showed similar failure characteristics (45°) to that observed under continuous cyclic with little effect of creep as shown in figure 5. Replicas taken on the surface after failure showed extensive grain boundary cracking, planar slip and some twinning as shown in figure 6. Also observed, an extensive oxidation on slip bands and grain boundaries. In general, the microscopic behavior of the hold-time test was similar to that under continuous cyclic except for the amount of oxidation. The crack growth was also at 45° with respect to specimen axis.

Fig. 5 a) Macrophoto of Waspaloy course grain: Torsion with hold time. (Spec. BF25, ΔY_T =1.55%, ΔY_{in} =0.643% @ N_f/2, N_f=2691, T=1200°F, t=90 Sec.) Note primary crack at 45° to the specimen axis on plane of maximum tensile stress.

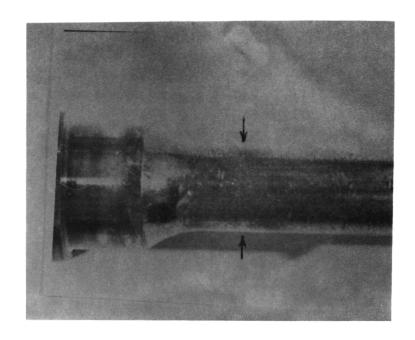
Fig. 6 a,b) Replicas of gage surface along the major crack at 40X. Mixed mode cracking is shown, grain boundary cracking, twining deformation, multiple slip system are observed.

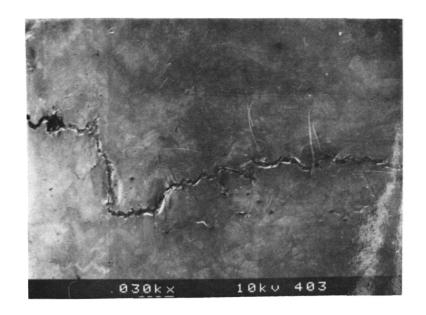
The axial hold-time test at 1200 °F, showed the failure to be normal to the loading axis as shown in figure 7. Scanning electron microscopy analysis

Fig. 7 a) Macrophoto of Waspaloy course grain: Axial with hold time. (Spec. BF8, $\Delta \epsilon_T$ =0.7%, $\Delta \epsilon_{in}$ =0.29% @ N_f/2, N_f=987, T=1200°F, t=90 Sec.) Note primary crack normal to the loading axis.

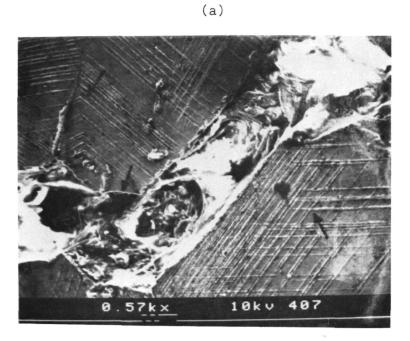
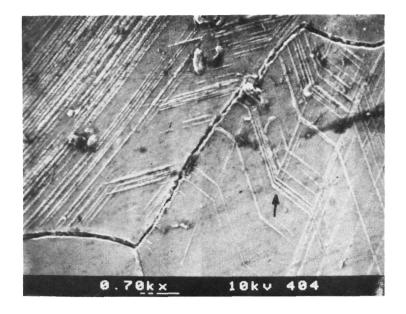
of the gauge surface, figures 8 and 9, showed mixed ode crack initiation: grain boundary cracking and slip band cracking. However, the propagation was mostly transgranular.

Fig. 8 a) Micrograph showing primary crack normal to the loading axis.

b) Mixed mode crack initiation and transgranular crack propagation. Note multiple slip systems operating, also deformation twining is observed.

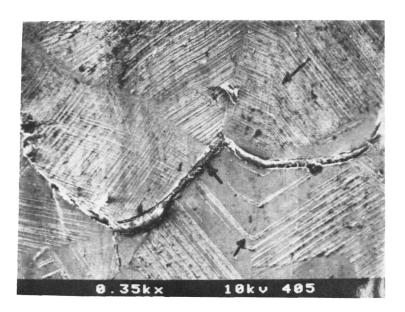
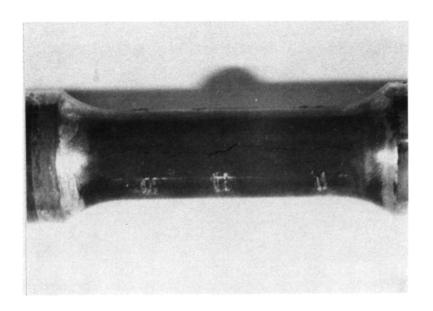
Fig. 9 a,b) Slip bands intersecting oxidized grain boundaries induced cracking, also multiple slip systems and deformation twining is observed.

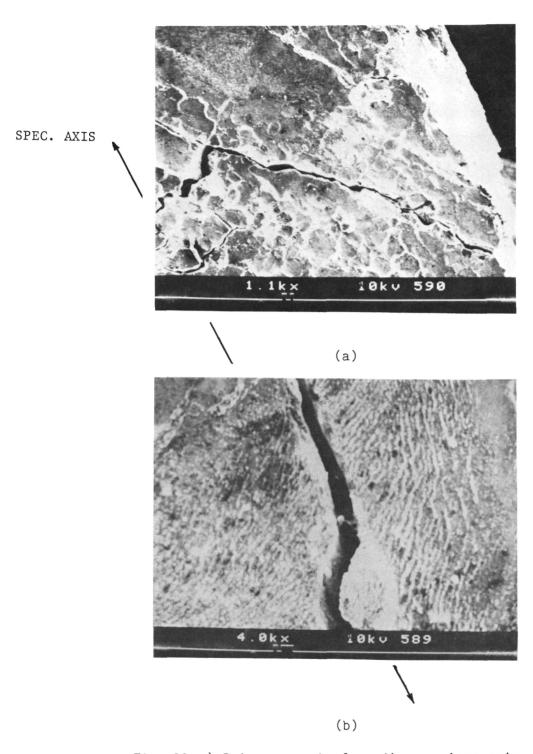
The torsional hold-time test of the fine grained specimen resulted in a shear mode failure (longitudinal crack along specimen axis) as shown in figure 10. The microscopic examination of the gauge surface showed extensive grain boundary oxidation and some grain boundary cracking that resulted in inter- and transgranular crack growth. Ill defined oxidized wavy slip bands (fig. 11), were observed rather than the strict planar slip that was seen in other described tests. Replicas taken on the surface are shown in figure 12. Creep showed an effect when compared to data obtained on coarse grain test.

Fig. 10 a) Macrophoto of Waspaloy fine grain: Torsion with hold time. (Spec.BA13, $\Delta \Upsilon_T = 1.94\%, \Delta \Upsilon_{in} = 0.558\% \ @ \ N_f/2, N_f = 1653, \\ T = 1200 \ ^\circ F, t = 90 \ \text{Sec.}).$ Note primary crack is along the specimen axis

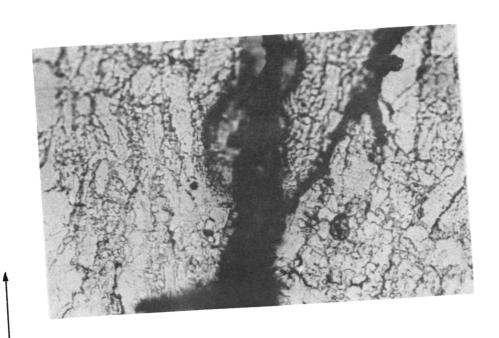
Fig. 11 a) Primary crack along the specimen axis, intergranular and transgranular cracking is observed, extensive oxiedation on the grain boundaries.

b) Note wavy and oxidized slip bands.

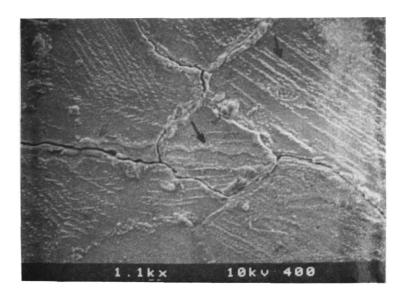
Fig. 14 a) Twin boundary cracking, oxidized slip bands are observed

b) Cracking along the grain boundaries, also note wavy slip bands

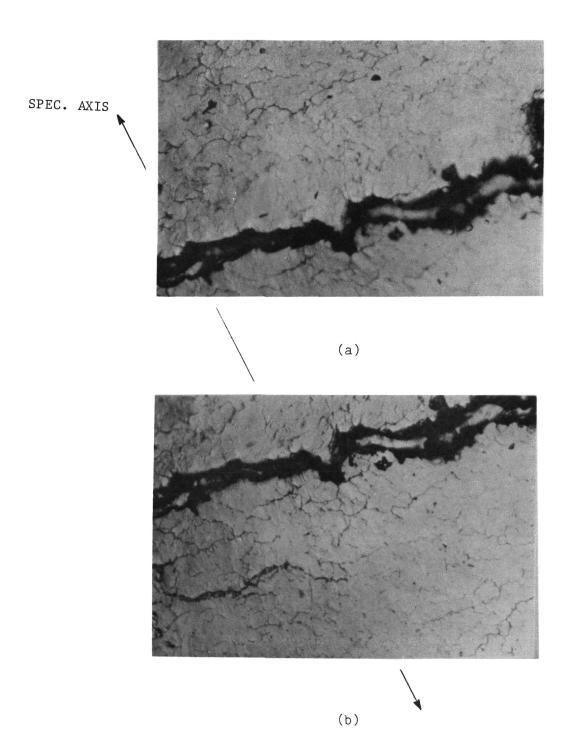
Fig. 15 a,b) Replicas of the gage surface at 40X, extensive grain boundary cracking above and below the primary crack are observed.
